Rural Access Power Points: A Challenge

**What could possibly go
wrong?
Answers**

**This PPT identifies the most likely reasons for the
various disasters.**

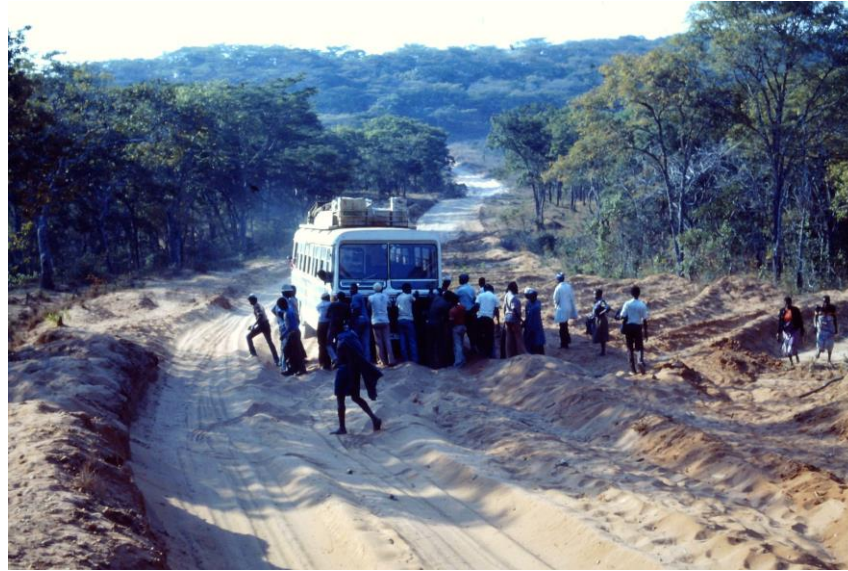
Road Surface

The road surface consists of the in-situ, generally single sized particle sand with no fines able to bind the material together. Any traffic displaces the material and vehicles get bogged down. The solution would have been to stabilise the material or cover it with a more robust surface material, unfortunately both expensive solutions.

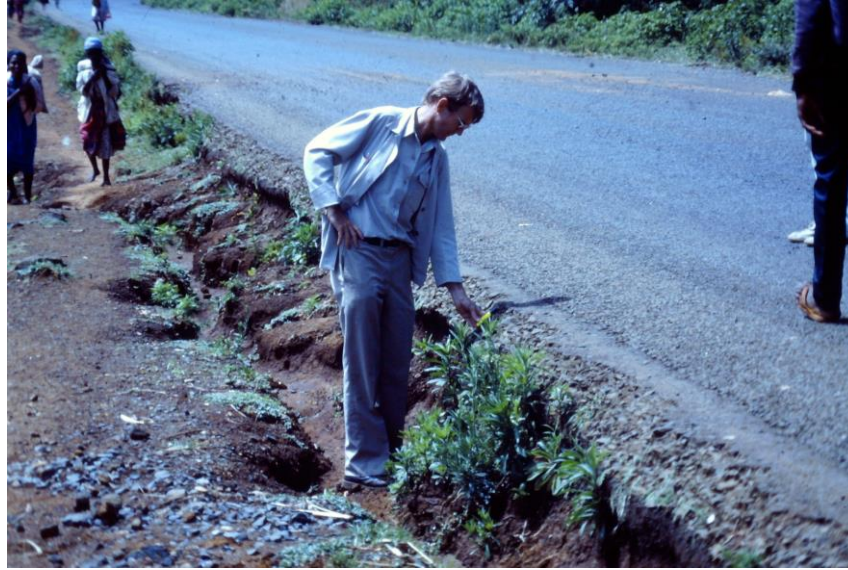
Shoulder

The road shoulder has been severely eroded by rainwater. The cause is inadequate drainage measures at the design/construction stage and failure to maintain the shoulder. Obviously a highly dangerous situation, particularly at night.

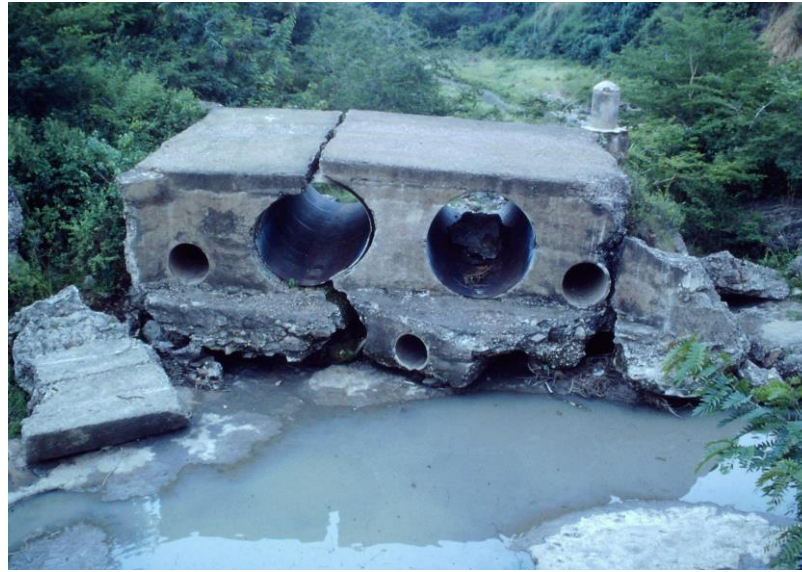
Drainage Structure

Where do you start?? It seems that attempts to ‘improve’ the structure have been made at various times – unsuccessfully! Design shortcomings indicate lack of peak flow capacity, lack of substructure and side seepage measures. There were also no restraints to prevent vehicles falling off into the watercourse.

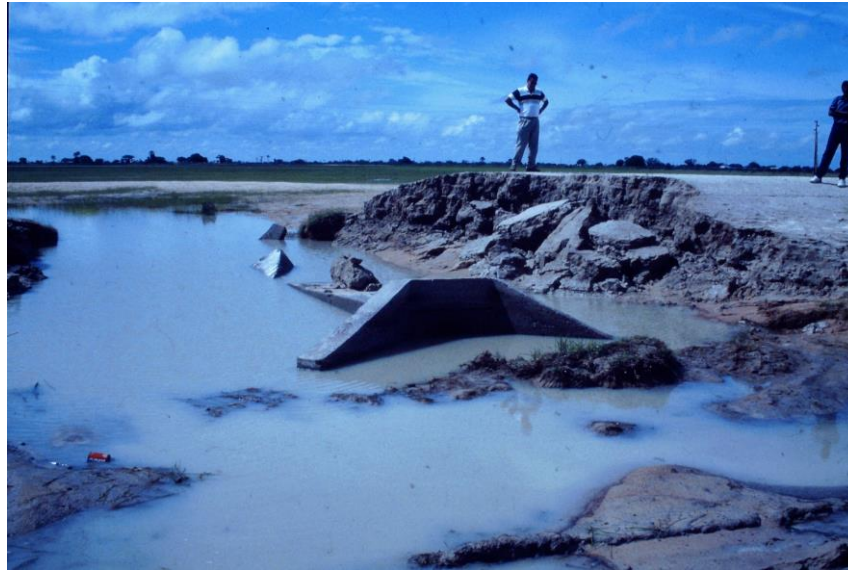
Drainage Structure

The culvert was substantially undersized and suffered from overtopping, support and backfill erosion, and foundation failure (absence of anti-seepage measures).

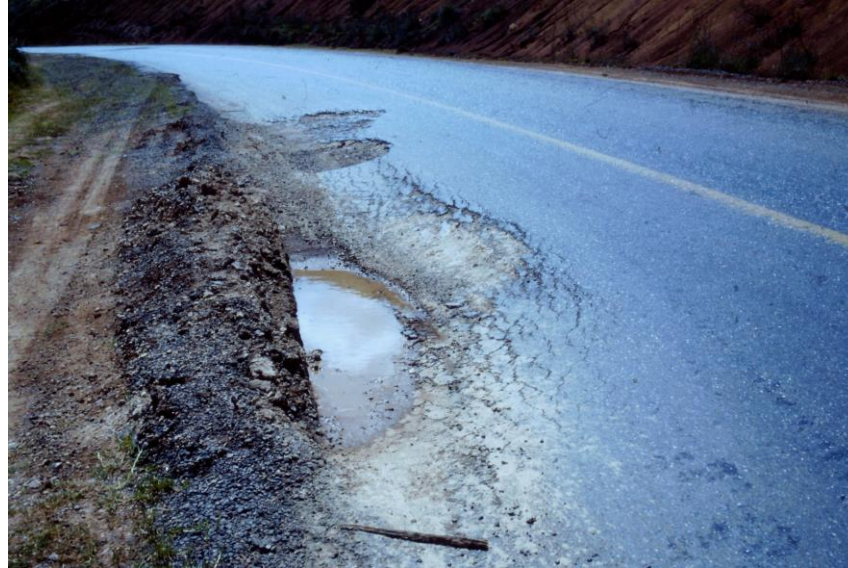
Multiple?

Poor pavement drainage arrangements and lack of timely maintenance. This was exacerbated by uncontrolled overloading of trucks.

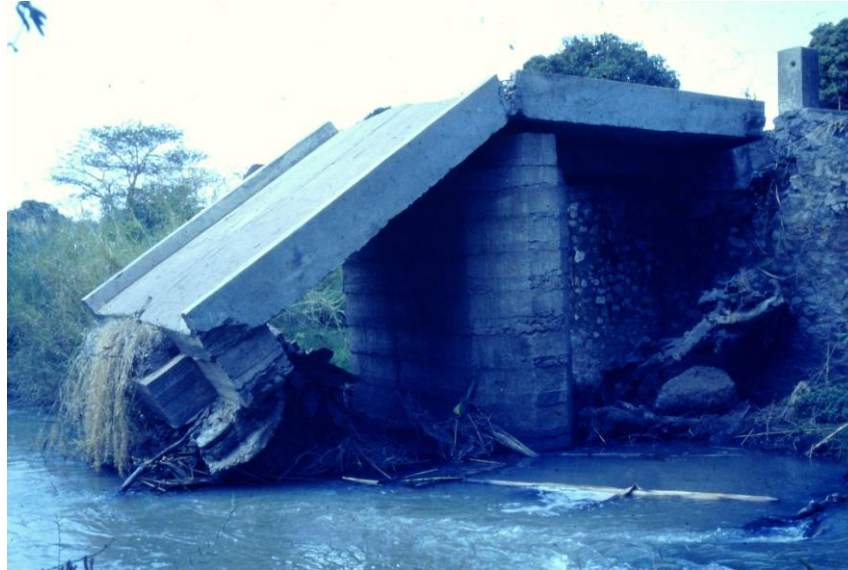
Structure

This image was taken in the dry season. The structure was obviously not designed long enough to bridge wet season flows leading to erosion of the abutment foundation and failure.

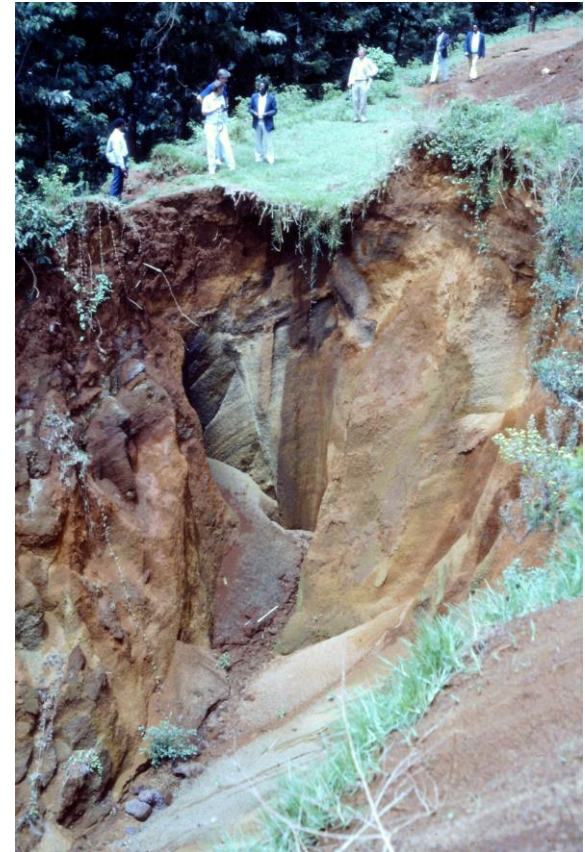
Drainage

This was the location of a side drain outfall on an unpaved rural roads on highly erodible soils.

Much greater care should have been taken in the design of drainage measures under the principle of 'little and often' to discharge accumulated rainwater safely onto the surrounding ground. This could have include bio-engineering erosion prevention measures.

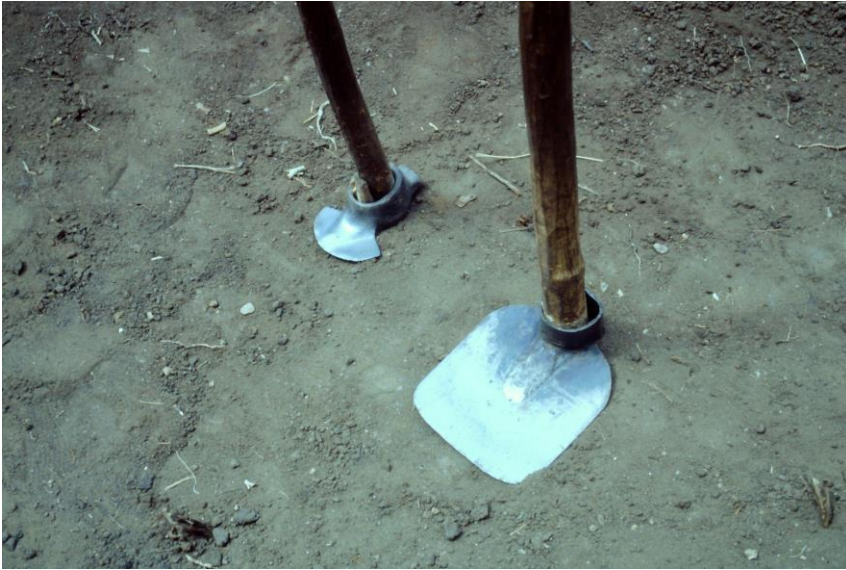
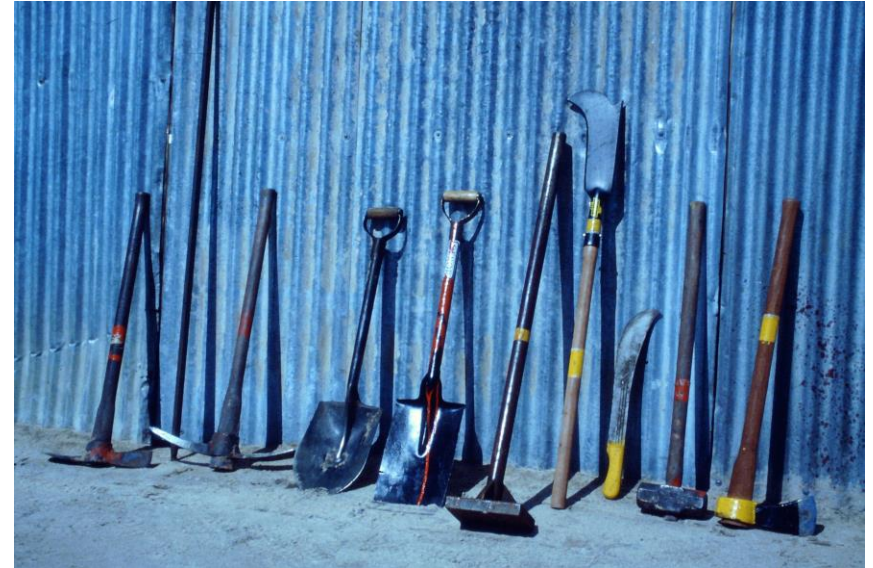
Productivity

The poor labourers were struggling to achieve the standard excavation task rates with these worn out tools with poor handles. Construction quality hand tools with properly designed handles should be provided as shown above right to achieve productive output.

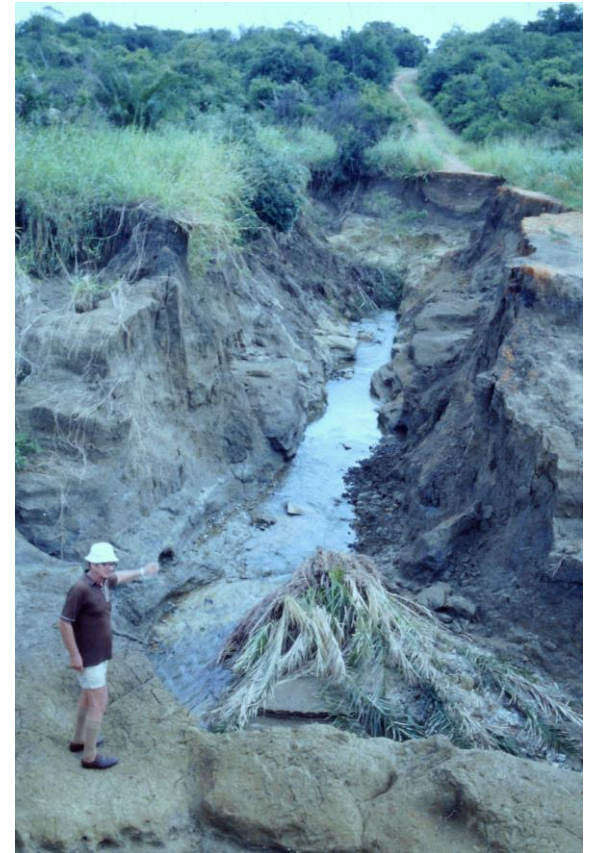
Drainage

The photograph was taken on the line of the original road.

This is obviously a significant watercourse crossing.

There was evidently failure to properly assess the characteristics of the watercourse, its stability and necessary measures to protect the structure and roadway.

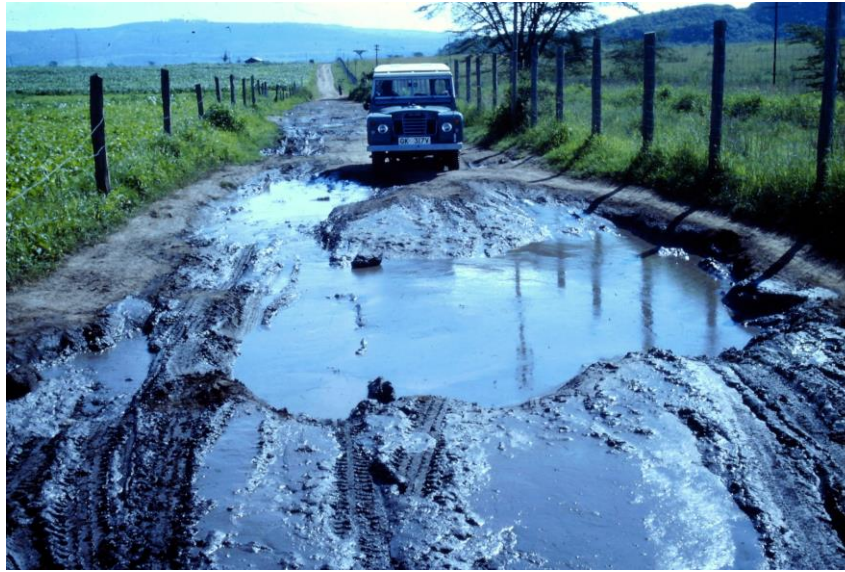
Drainage

The classic absence of camber, side drainage and water dispersal measures, and of course maintenance.

'Highway' should be implemented as a means of passage ABOVE the surrounding ground!
